Mesier Homestead Wappingers Falls, New York

Exterior Paint Chromochronology

October 3, 2006

prepared by Richbrook Conservation New York New York

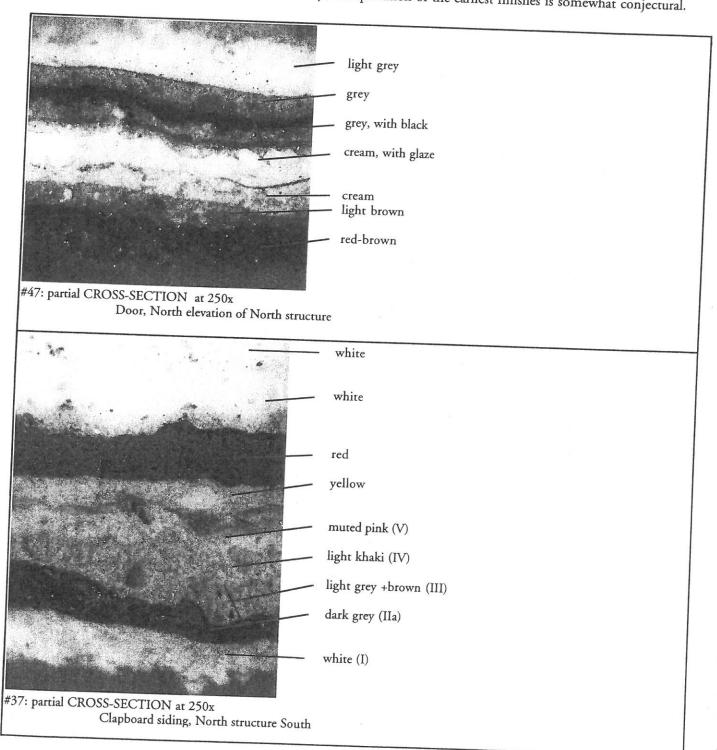
PHASE I

Phase I represents the earliest finish on what is believed to be the earliest segment of the building, that is the North structure. At this time, the clapboard was painted white, and the fieldstone masonry was whitewashed. The earliest finish on the rear plank door, which may also represent the earliest construction, is a red-brown. Because of later interventions, removal of siding from the North elevation, and the disconnect between this North structure and the later South structure during the mid- 18th century, interpretation of the earliest finishes is somewhat conjectural.

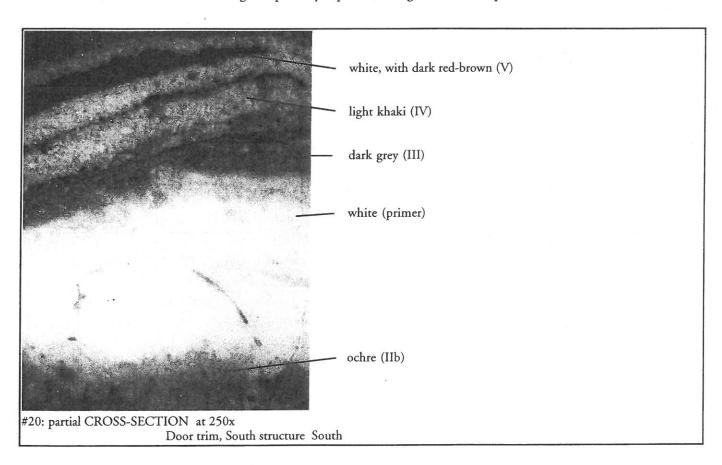
PHASE IIb

Phase IIb represents the earliest Ochre finish on the original siding of the South structure, clapboard siding which had a beaded detail at the edge. Complementary trim finishes were not specifically found on the samples, suggesting that at a later date, such as when the siding was partially replaced, a large scale trim replacement was done.

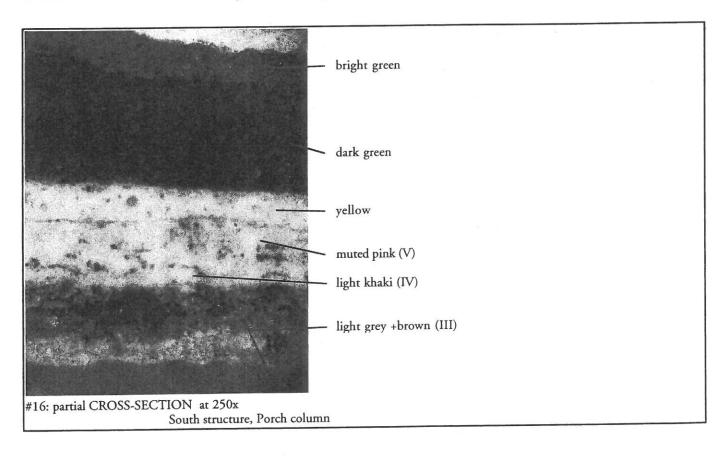
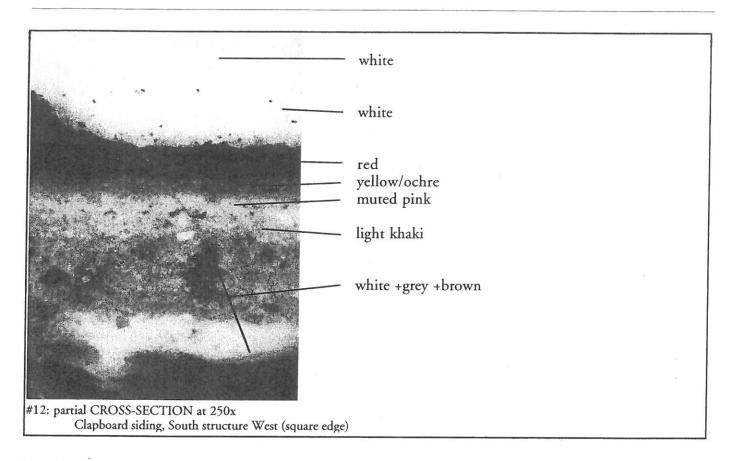
PHASE III

During Phase III, all siding was refinished uniformly, and some clapboard were replaced, either due to extraordinary wear or to related modifications. The replacement clapboard differ from the original clapboard in that they lack the decorative beaded edge detail. This Phase III finish was done in a Light Grey paint, with evidence of possible decorative treatment based on the discrete and variable appearance of a brown layer at the surface or alternately a dark olive layer. This might have been a finish used to resemble stone, which was commonly done to enhance the appearance of an otherwise modest wood building, and make it seem more substantial.

Window and door surrounds at the North and South structures were painted Dark Grey during this period. This is also the earliest finish found on the elements of the south-facing verandah, indicating that this was added at the time that clapboards were replaced and potentially other elements repaired or altered. It is notable that the porch ceiling panels and moldings, like the replacement clapboards, were primed with white prior to application of the grey paint, while other porch elements including columns and cornice were not primed in this manner. This may have been a function of the wood chosen for flat panels or siding versus decorative or milled elements.

This Phase III finish, based on its overall application to both structures, and its appearance as the earliest finish on many of the trim elements, is interpreted as the first Mesier campaign, shortly after 1776 when he acquired the house. It can be conjectured that when he first purchased the property, he made widespread changes to many of the trim and siding elements, and added the verandah, refinishing the whole in this grey, potentially "stone-look" scheme. While this would be the logical choice for recreation of a historical period finish, the decorative intent is not necessarily established by the samples viewed in cross-section, and the current weathered condition of the existing paint layers in situ precludes the option of small-scale exposures of the finish. Some decorative interpretation of the observed finish layers may be required for replication.

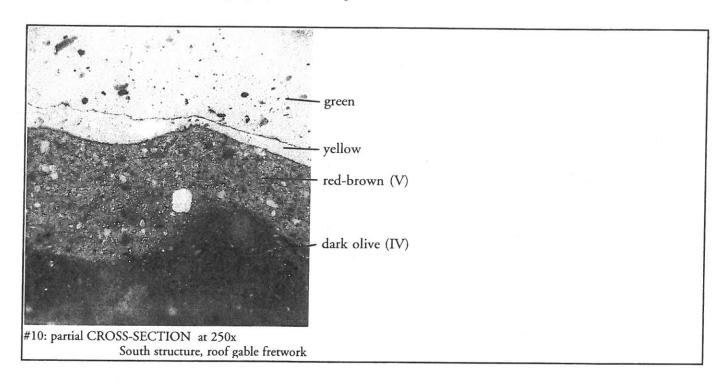
PHASE IV

Phase IV represents an interim refinishing, pre-dating the construction of the connector between North and South structures. The siding appears to have been painted a Light Khaki, while the window and door surround trim was painted Dark Olive. This may have constituted a partial, or touch-up refinishing effort, as not all samples contain this layer within the structure, and may therefore have been done to address specific and discrete modifications such as the addition of the fretwork embellishments. These Victorian embellishments would likely have been added later in the 19th-Century, potentially after the 1858 death of Matthew Mesier, when his children took over the property, but prior to the 1891 donation of the property to the Village.
