**MESIER HOMESTEAD
EXISTING CONDITIONS REPORT
WAPPINGERS FALLS, NEW YORK**

June 1997

prepared by
**Preservation Architecture
51 Round Lake Road
Valatie, New York 12184
518-766-2459/2451**

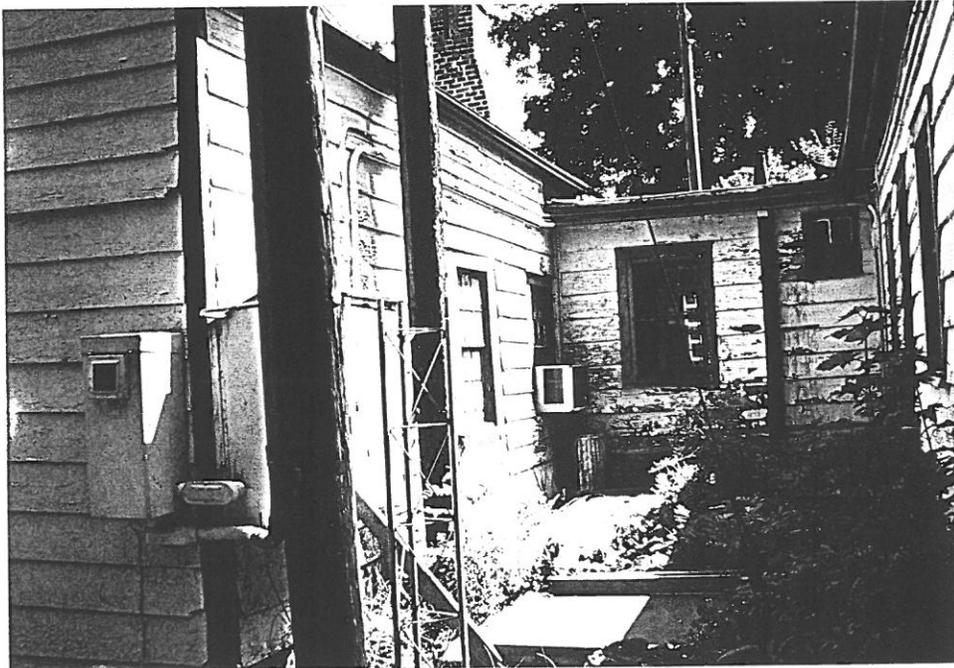
Top: South Section, north elevation.
Bottom: Courtyard between North Section, south elevation (left) and South Section, north elevation (right). At center is undated Connector.

The soffit and fascia of the west side of the Connector between the North and South Sections has exhibited substantial damage due to the failure of gutters and down spouts.

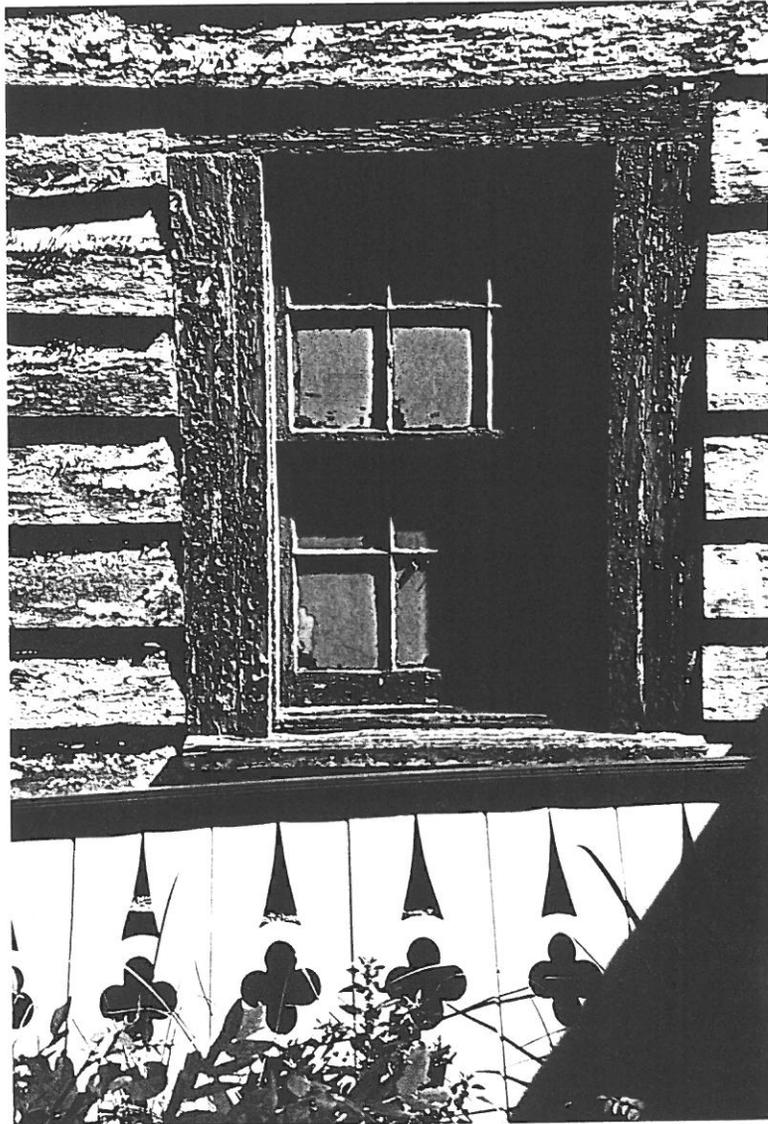
Paint Condition, North Section

Paint is in extremely poor condition. In isolated areas, rot has occurred and replacement will be required. Particular areas of deteriorated siding:

Repainting of the entire building, to be based on laboratory paint analysis, should occur. Preparation for repainting should include removal of all existing paint using scraping and sanding techniques, and, at select locations, heat under controlled conditions. Wood should receive restorative coatings, and for some conditions epoxy consolidation may be appropriate. All new and existing wood should be primed and painted.

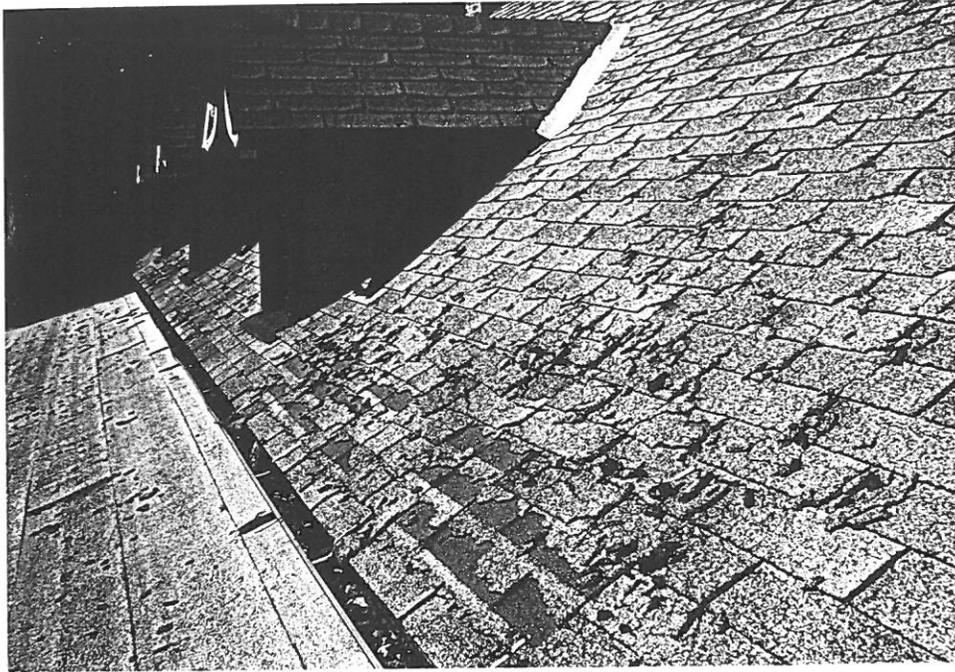
Top: Roof condition, South Section, south slope.
Bottom: Chimney condition, South Section.

The South Section's north and south slopes are covered with asphalt shingles. These are generally in extremely poor condition. Shingles are missing, curled and cracked. The northwest corner of the north slope exhibits extensive amounts of biological growth. This growth indicates the inability of that roof area to dry out, and may be the cause of damage of interior finishes and structural members.

All existing roofs should be removed and an entire new roofing and drainage system installed. Selective removals should occur to determine the original materials and details that may be used in the restoration. Historic photographs and other documents should also be used in planning the restoration. It is assumed that the original roofs were wood, and that the mid-20th century roofs were tin.

Included in the roof replacement project should be the removal of existing roofs and decking; installation of new wood decking and necessary structural repairs; (as determined historically appropriate) the installation of wood shingles and flat seam metal roofs on the gabled portions, dormers, and Veranda, and a membrane roof on the (invisible) flat section; the installation of new copper flashing between roof slopes and at chimneys; the installation of new wood gutters and downspouts; the repair and restoration of wood cornices and decorative wood elements on the roof; and the restoration of brick chimneys.

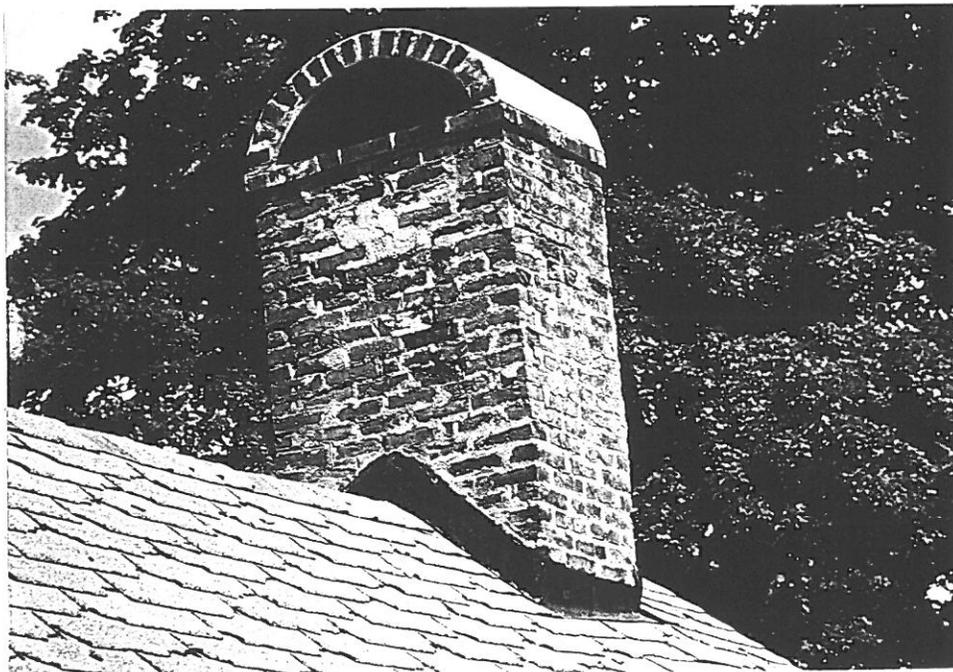
The six chimneys range from sound condition to having extreme deterioration of bricks.

Recommendations: All flashing on existing chimneys should be removed and replaced as a part of the roof restoration project. At the same time, partial or complete rebuilding of the chimneys should occur using sound existing brick and/or and new brick to match original, and soft lime mortar.

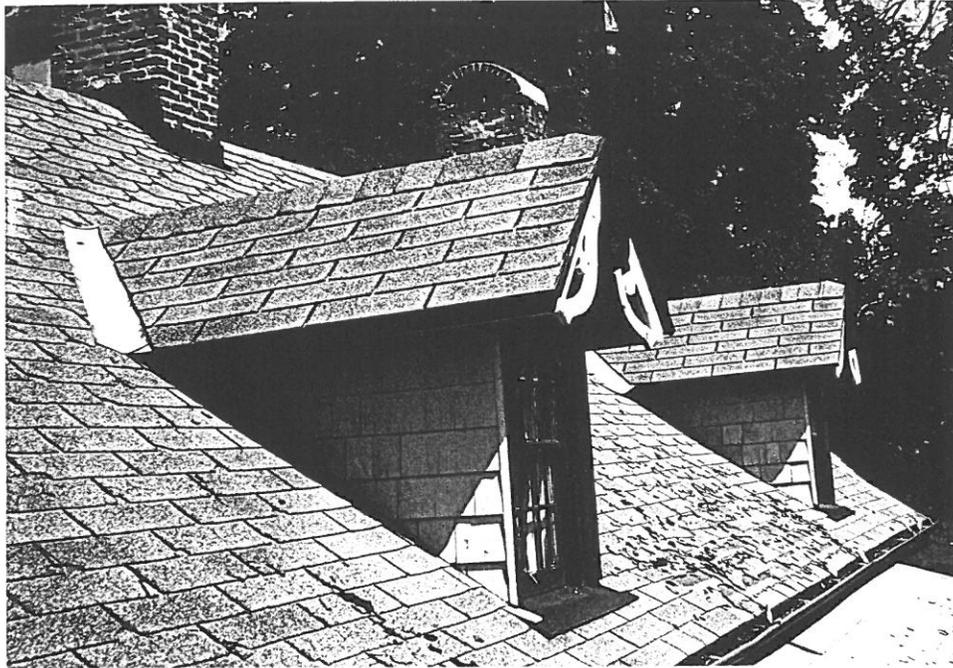
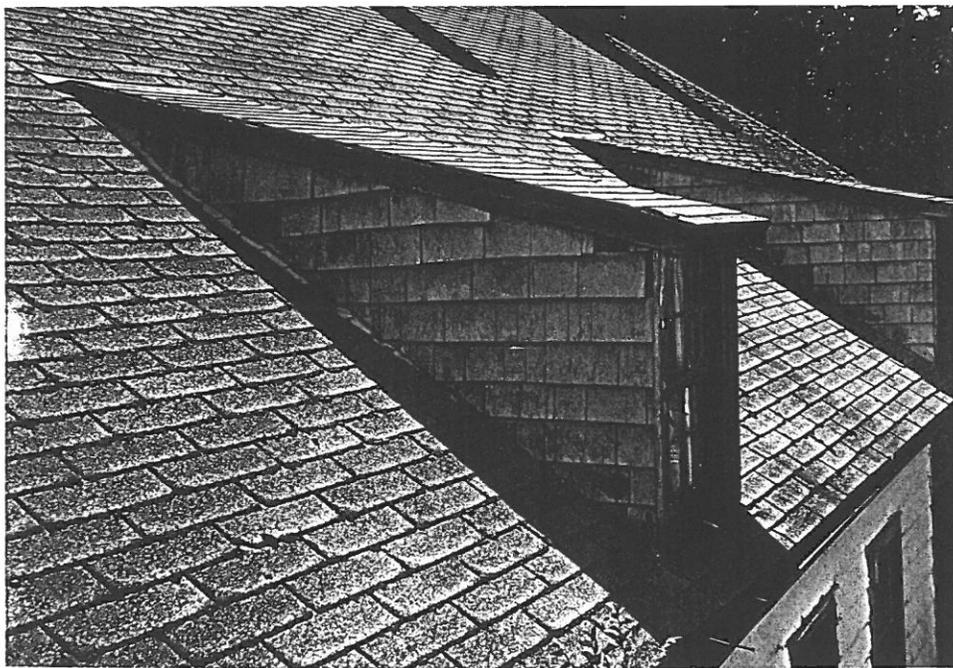
Top: South facing dormer, South Section.
Bottom: North facing dormer, South Section.

The dormer roofs are of more recent vintage but also in deteriorated condition. Shingles are deteriorated or missing. The gable roofs on the south facing dormers overhang the dormer walls, offering protection from water infiltration and ice. In contrast, the two north facing shed dormers have little overhang, and water problems here are more likely.

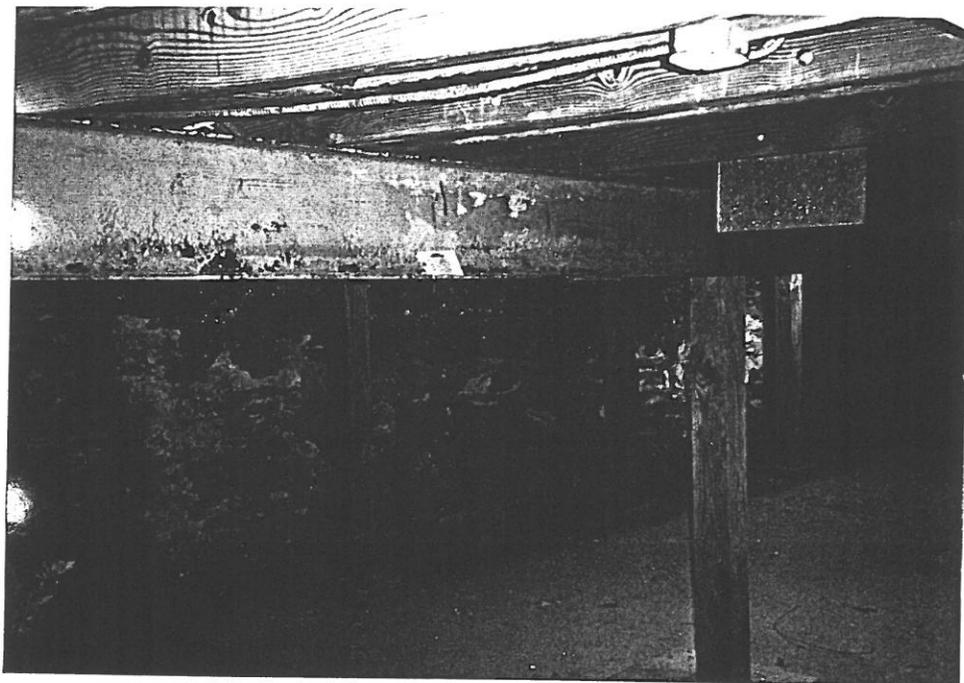
All sections of the Homestead are of wood frame construction. Only the South Section has a basement, which was substantially reinforced in recent years with the addition of wood columns supporting steel beams and new floor joists and beams. The basement is in very good condition, although the southeast corner shows evidence of water leakage, likely caused by exterior drainage problems.

Top: Basement, structural reinforcement.
Bottom: Basement, southeast corner, indications of water penetration.

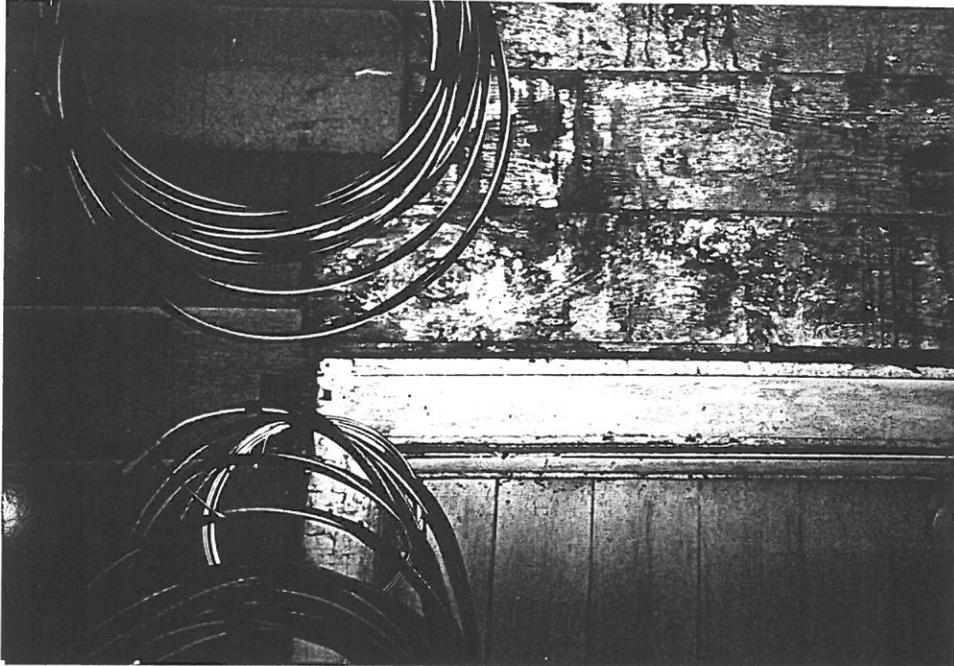
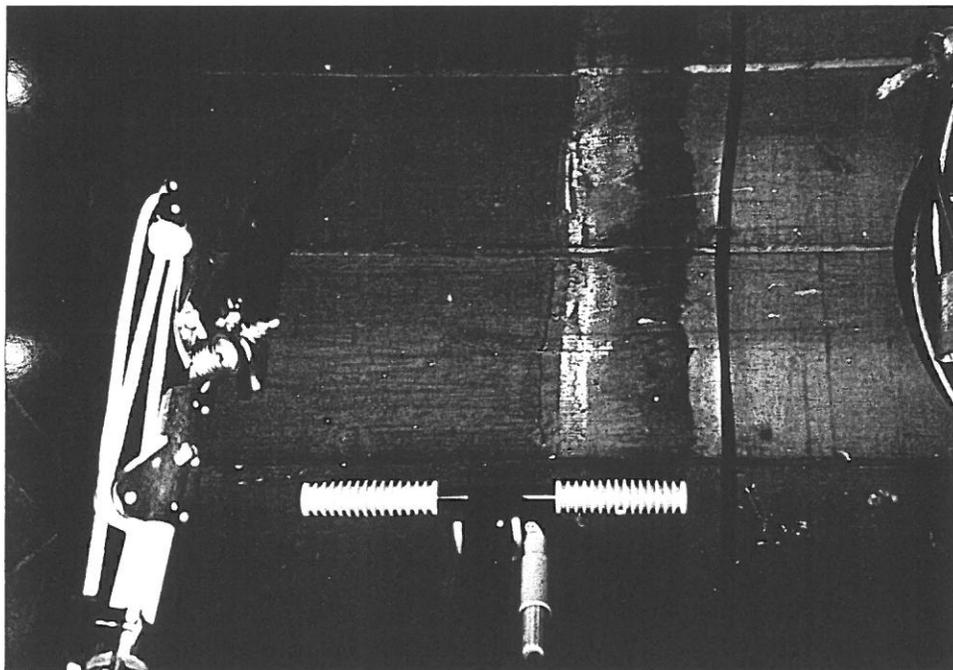
Top: North Section, north elevation, evidence of alterations and earlier structure.
Bottom: North Section, north elevation, evidence of alterations and earlier structure.
