Mesier Homestead Wappingers Falls, New York

Exterior Paint Chromochronology

October 3, 2006

prepared by Richbrook Conservation New York New York

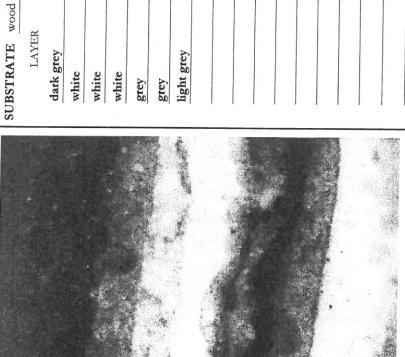
North elevation door **JCATION**

NOTES			. 1	+glaze?			Activities of the second of th	modern		3.	
BSTRATE wood	LAYER	red brown	lt brown	cream	cream +g	grey +black	grey	light grey	lime green mo	dk red brown	dk red brown

d was built, the lime green may represent interior phase, while the later dark red
