**MESIER HOMESTEAD
EXISTING CONDITIONS REPORT
WAPPINGERS FALLS, NEW YORK**

June 1997

prepared by
**Preservation Architecture
51 Round Lake Road
Valatie, New York 12184
518-766-2459/2451**

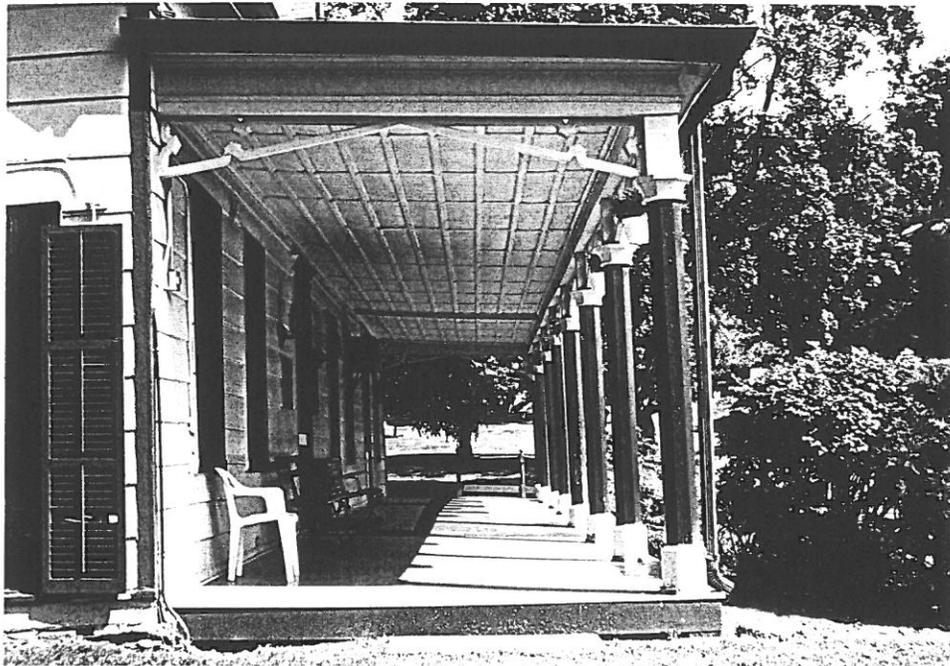
Top: Veranda, west elevation.
Bottom: South facing dormer, barge board detail.

The Veranda roof is noted in the HABS drawings as having a tin roof. It is currently covered with rolled lap roofing and is in extremely poor condition.

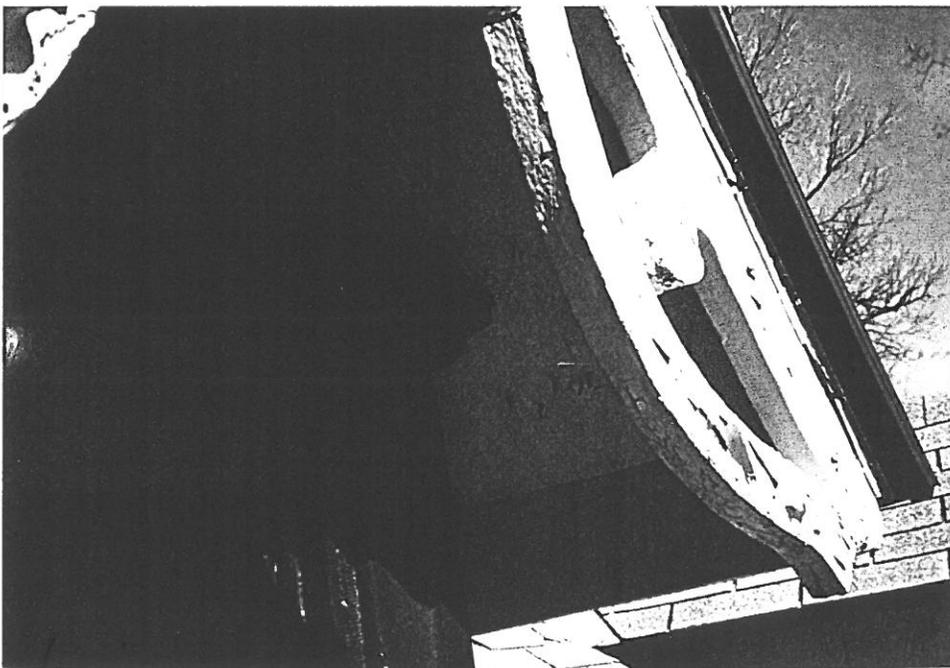
The dormer roofs are of more recent vintage but also in deteriorated condition. Shingles are deteriorated or missing. The gable roofs on the south facing dormers overhang the dormer walls, offering protection from water infiltration and ice. In contrast, the two north facing shed dormers have little overhang, and water problems here are more likely.
